TRW MATERIALS COMPATIBILITY STUDY WITH
ETHYLENE OXIDE/FREON 12 DECONTAMINATION PROCESSES

CONTRACT NO. NAS8-20864

TRW No. 09133-6003-R000

September 14, 1967

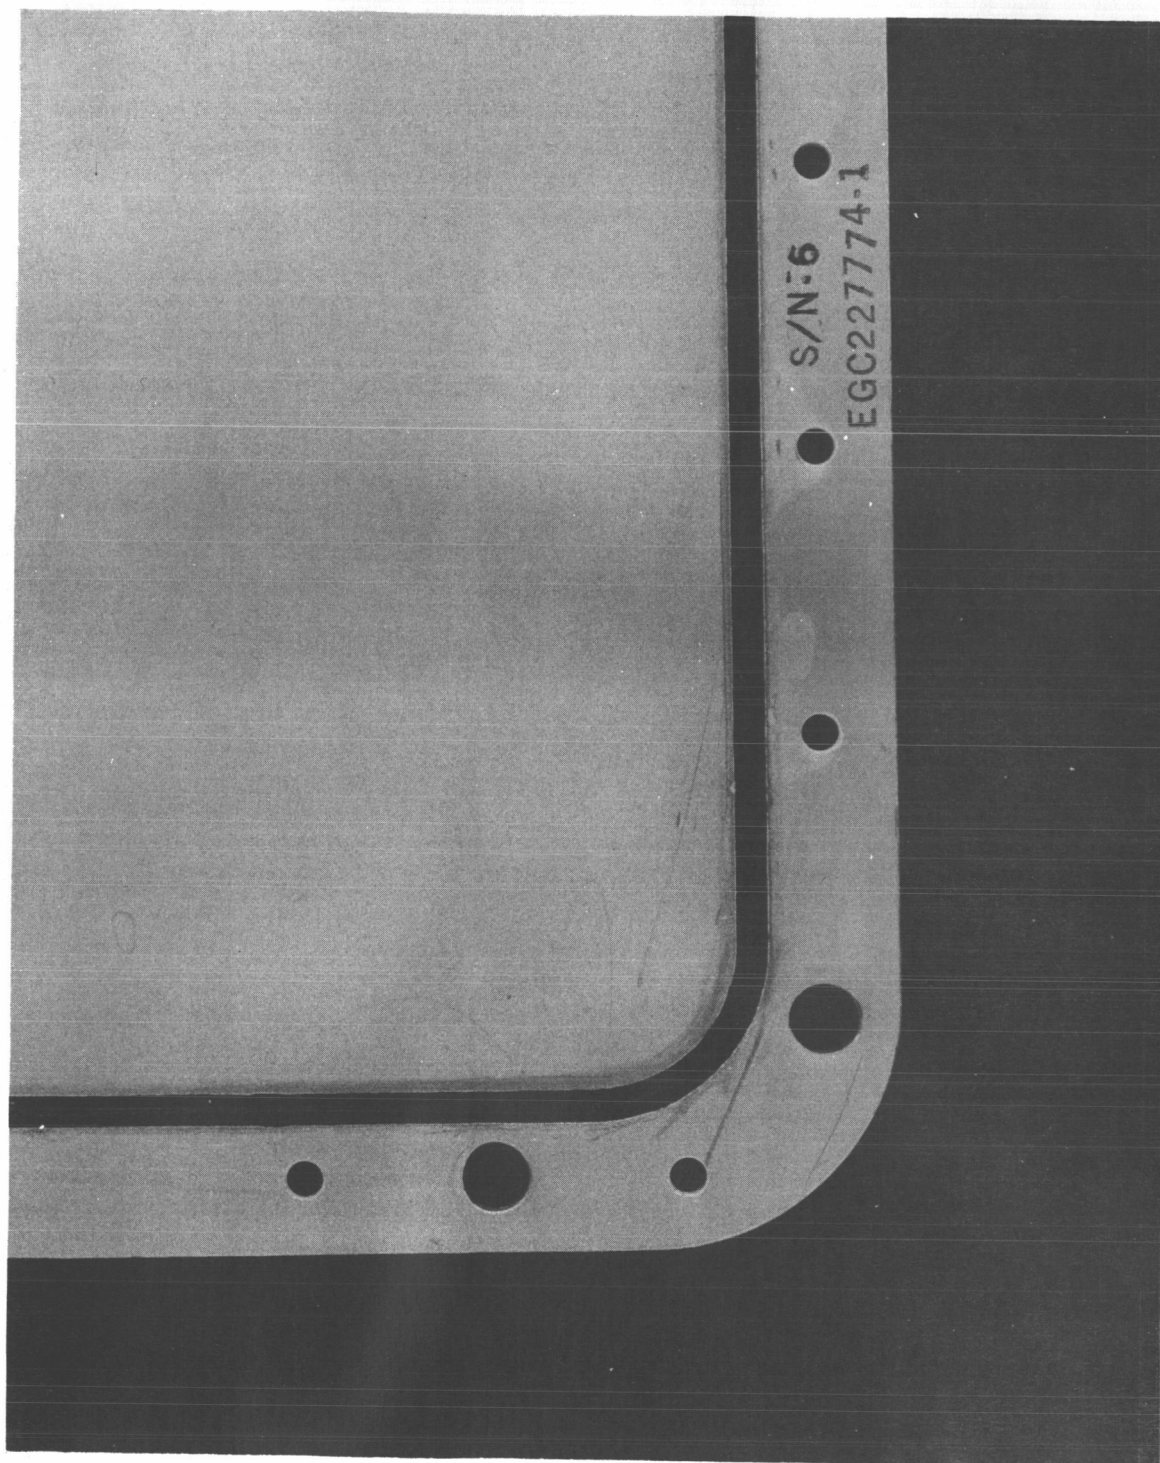
FIGURE 14. Electrical J-Box O-Ring (Butyl) before ET0/Freon 12. Color Photo (Neg. #32621-67)

The Butyl Rubber J-Box O-Ring (Figures 14 and 15) retained normal size and indications are that there were no deleterious effects from ETO/Freon 12. Little damage was noted on the electrical harness samples, (Figures 16, 17, and 18). The insulation, probably irradiated polyolefin, became a little tacky, but was still serviceable. The RTV potting compounds were unaffected both visually and dimensionally. The insulation materials were undamaged. The sealing material, alkanex, which is used to hold the insulation to the connector, was damaged, but the seal was not broken.

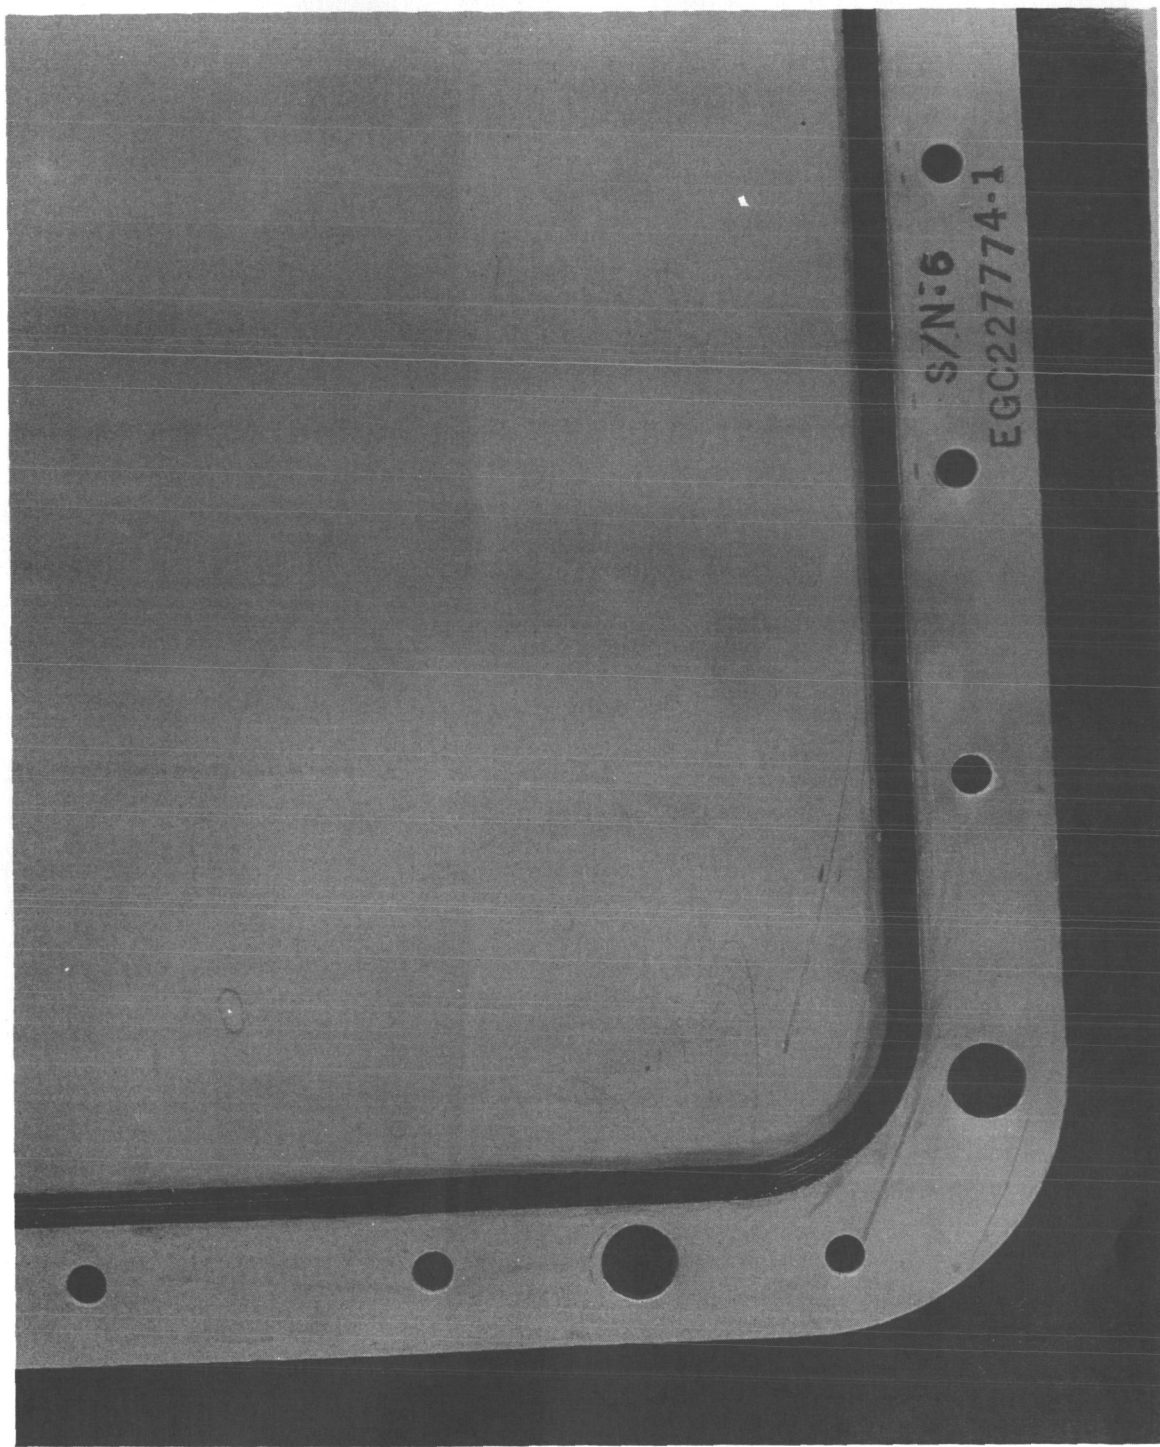
FIGURE 15. Electrical J-Box with Butyl O-Rings after 7 cycles ET0/Freon 12. No apparent visible changes noted. Color Photo (Neg. #33011-67)

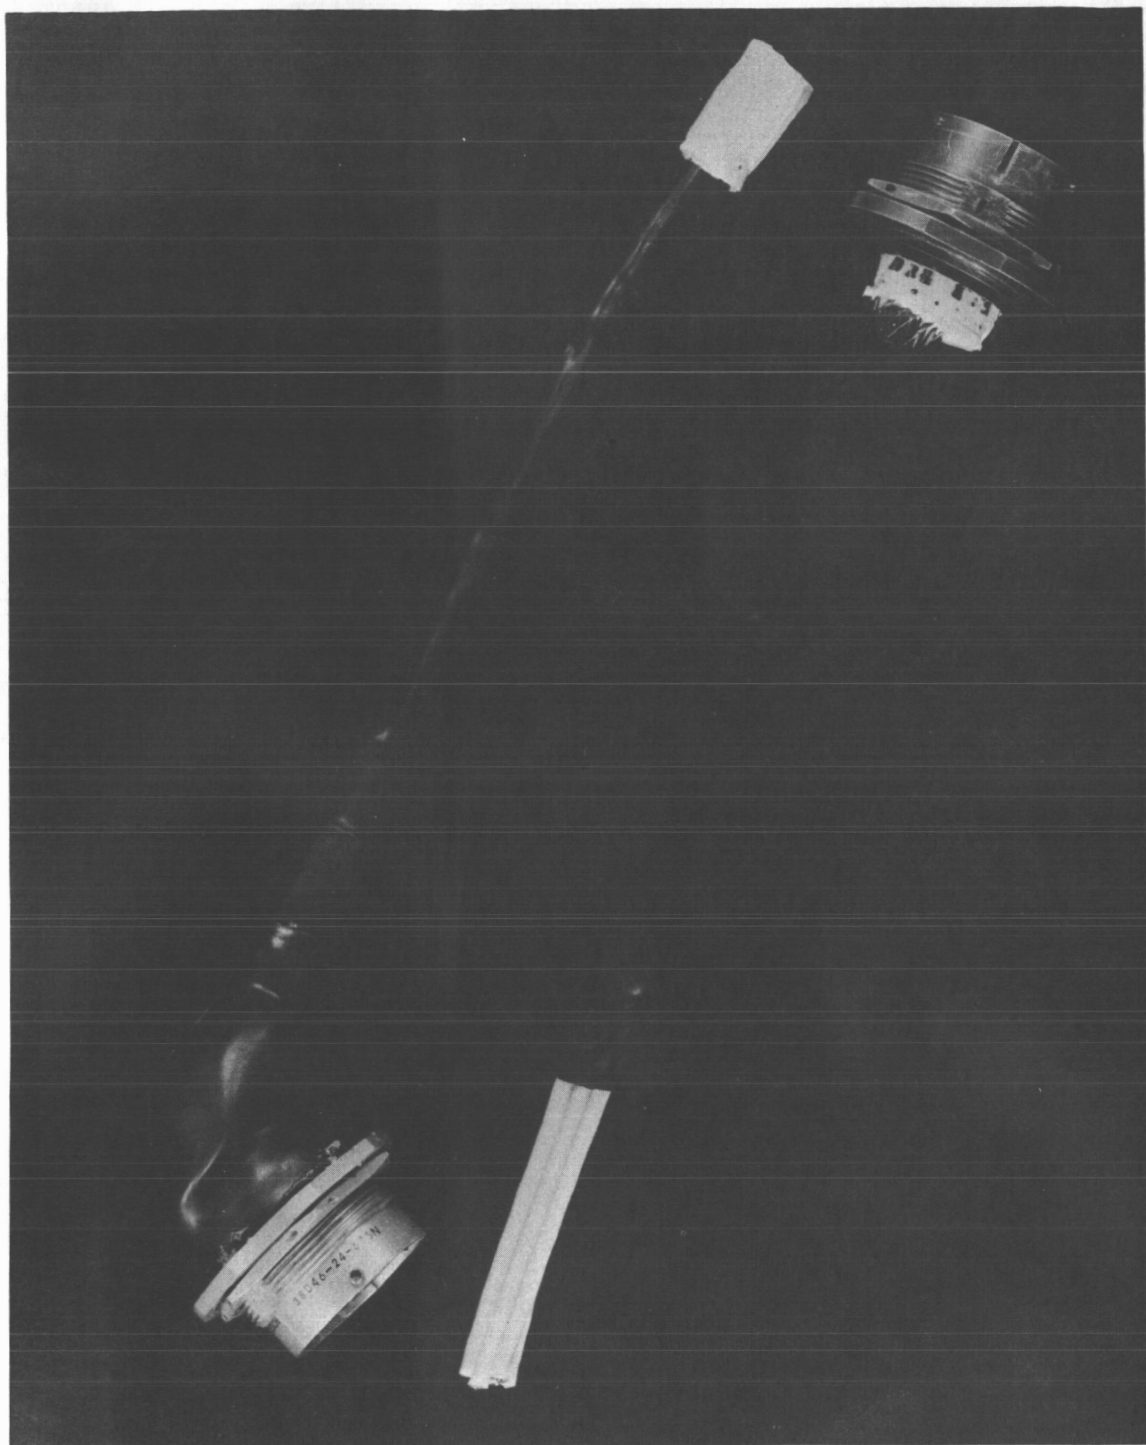
FIGURE 16. Electrical Harness Samples (PT2-96-196, Removable Type Contacts) before ETO-Freon 12. Color Photo (Neg. #32615-67)

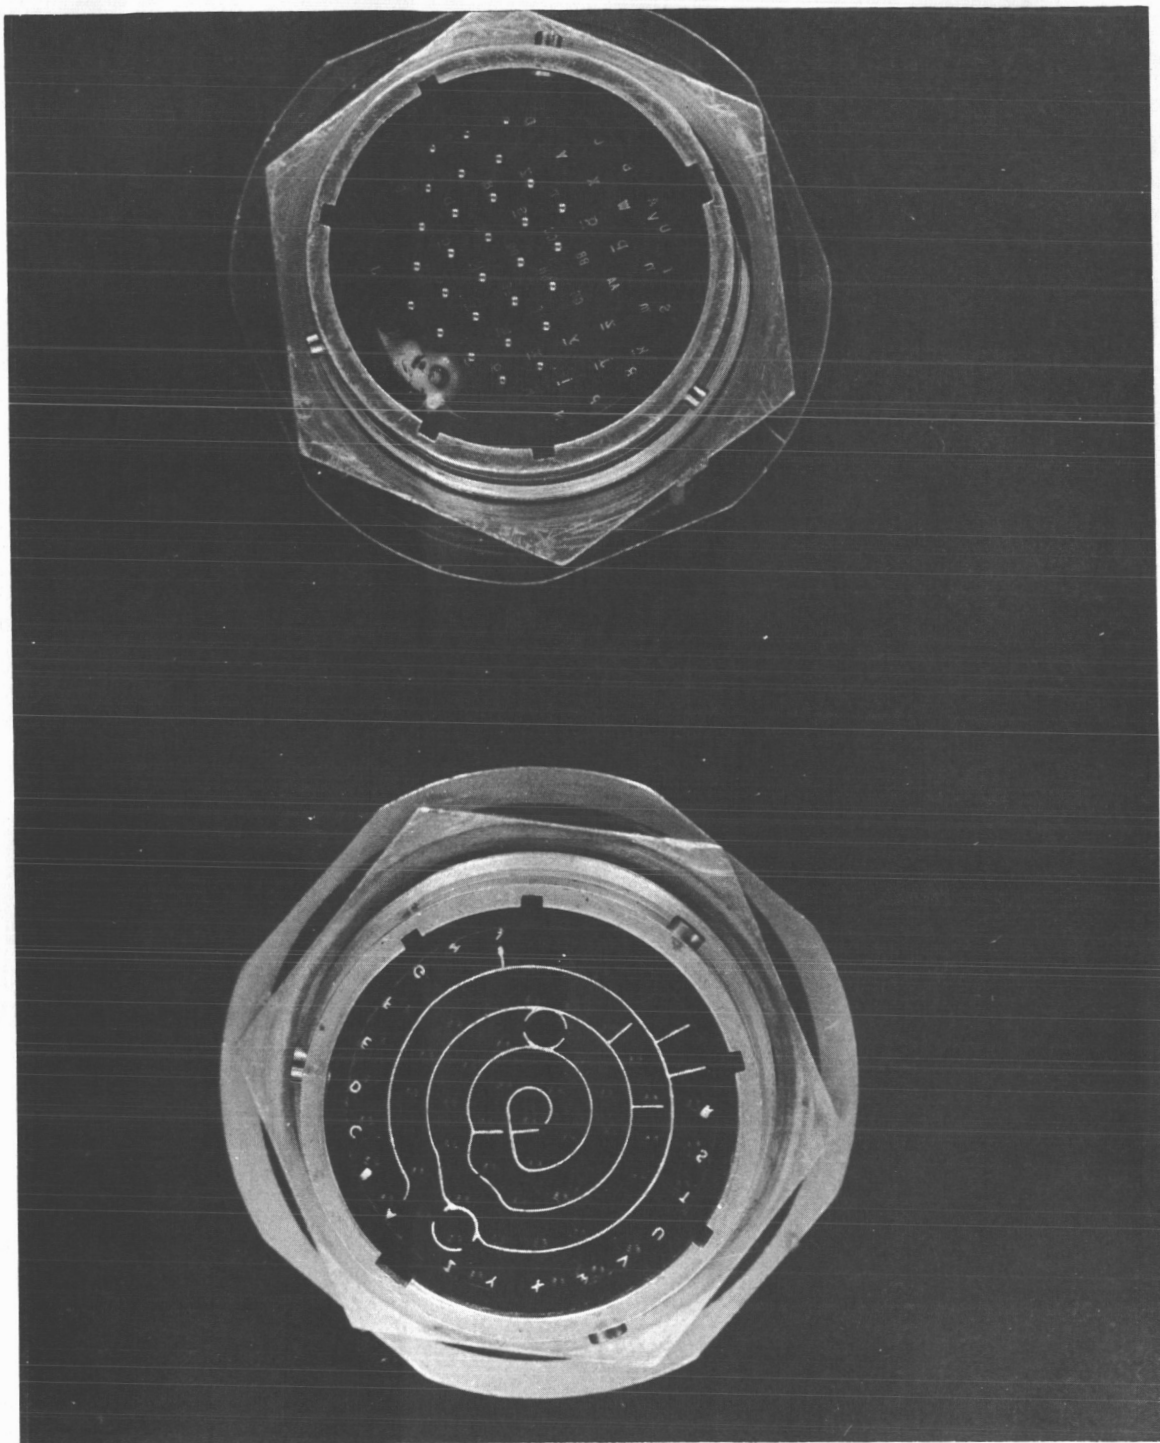
FIGURE 17. Looking into electrical connectors (PR 2-96-196) before ET0/Freon 12. A photo after ET0/Freon 12 was not taken as there were no visible changes. Color Photo (Neg. #32617-67).

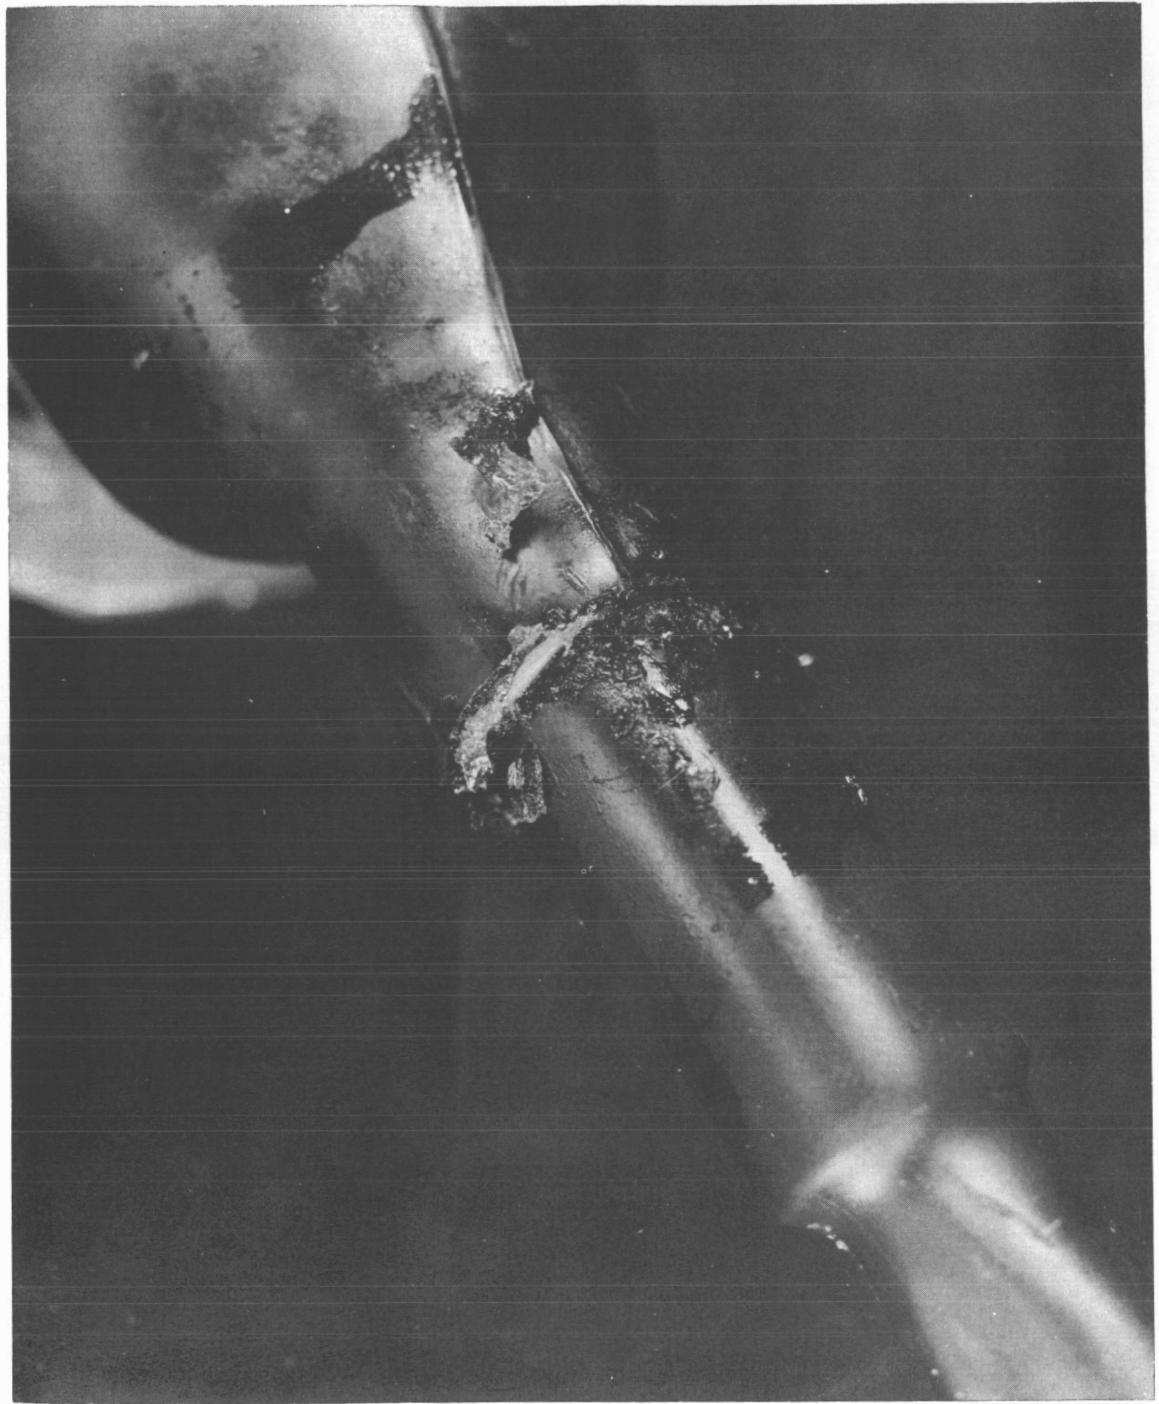
FIGURE 18. Electrical Harness material after 7 cycles ETO/Freon 12. Note sealing material peeling off. Color Photo (Neg. #33019-67)

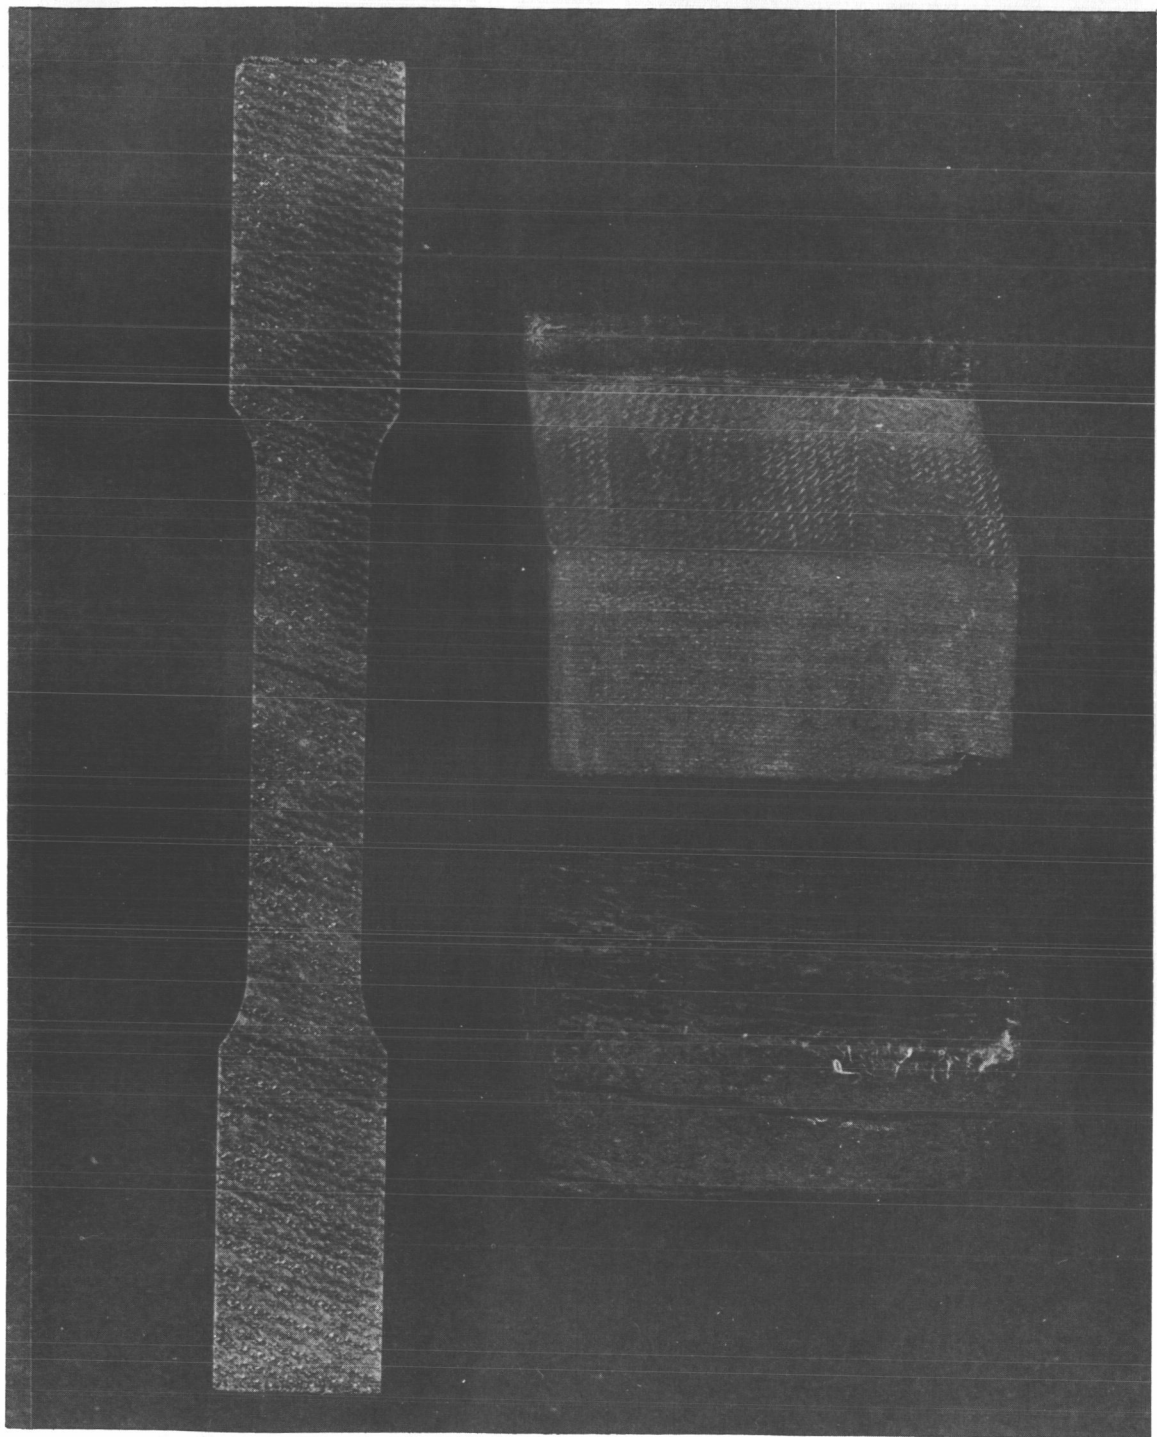
FIGURE 19. Right Top - MX 2600. All before ET0/Freon 12. Color Photo (Neg. #32619-67). Right Bottom - MX 7208 Insulation Overwrap. Left - MX 2600 Tensile Specimen.

The ablative materials for the combustion chamber, MX 2600 Phenolic Silica Laminate, MX-SE 57 Rubber Modified Phenolic Silica Laminate, and WB 7208 Insulation Overwrap, exhibited some change after ETO/Freon 12. Visually, all specimens showed some bleaching after ETO/Freon 12 (Figures 19, 20, 21, 22, and 23). MX 2600 and WB 7208 showed weight increases from 3.4 percent to 7.6 percent (Table 5.) No changes in hardness were noted (Table 6). There was a drop in tensile strength of 17.8 percent in MX 2600; 7.1 percent in MX SE 57; but an increase of 6.9 percent for WB 7208 (Tables 7, 8, and 9). There was a drop in Modulus of 32.8 percent in MX 2600; of 7.5 percent in MX SE 57; and 16 percent in WB 7208. All ablative materials tested appear to be compatible with ETO/Freon 12.

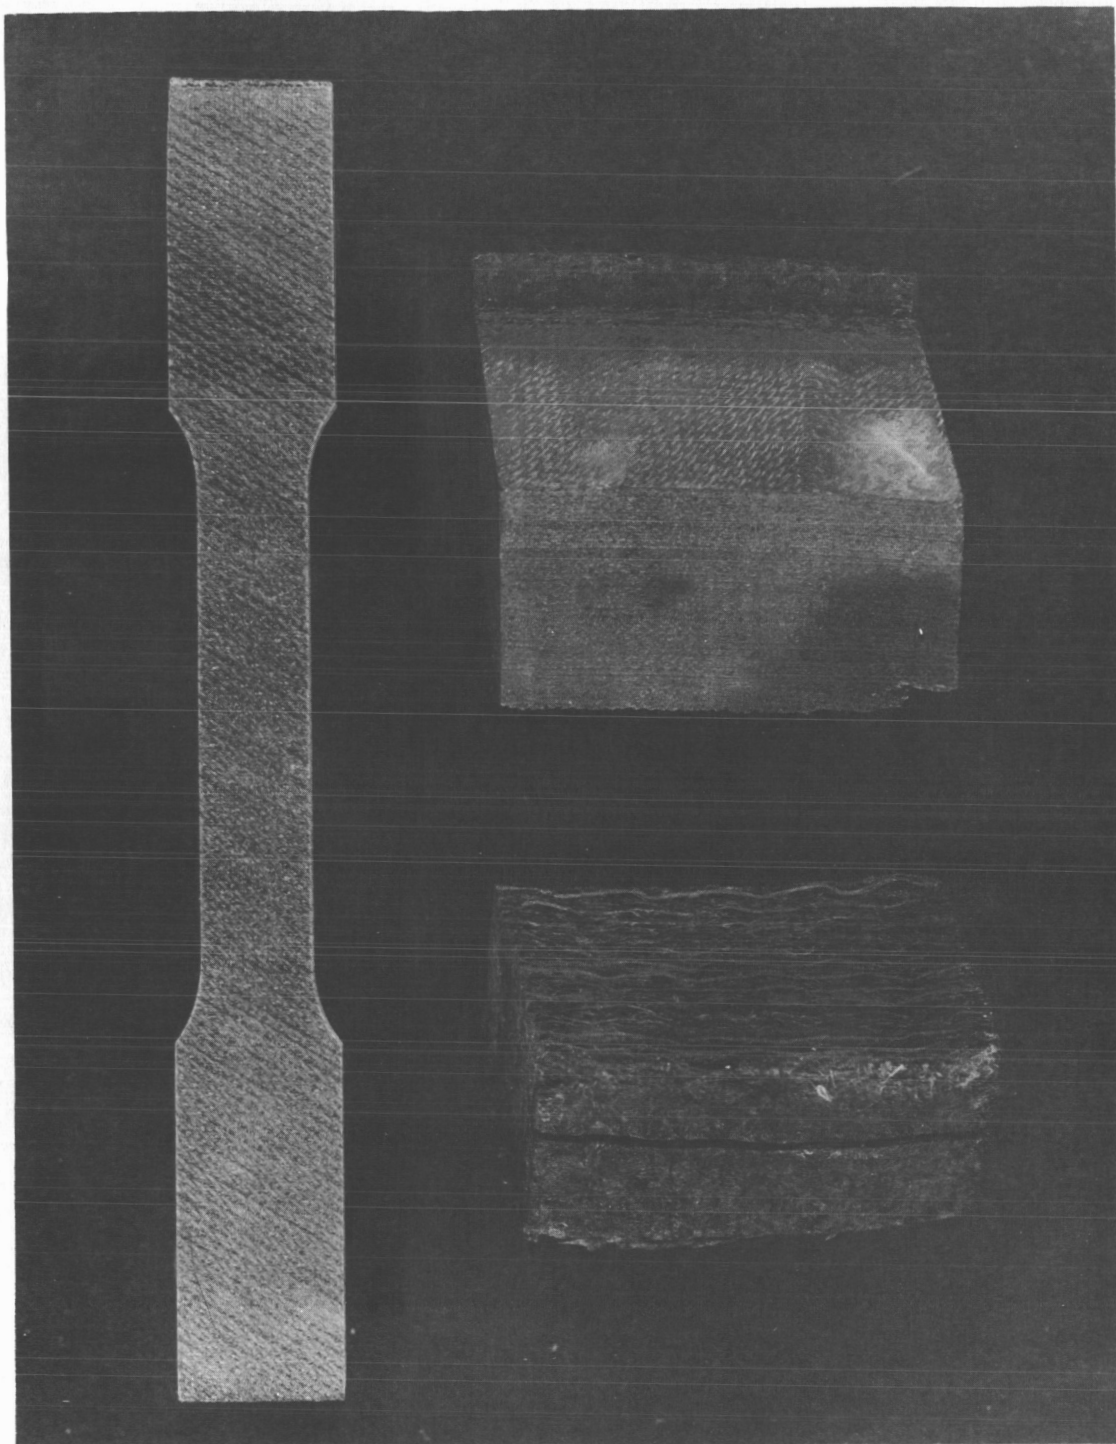
FIGURE 20. Right Top - MX 2600 after 7 cycles of ET0/Freon 12. Note slight bleaching effect on samples. Color Photo (Neg. #33016-67). Right Bottom - Insulation Overwrap. Left - MX 2600 Tensile Specimen.

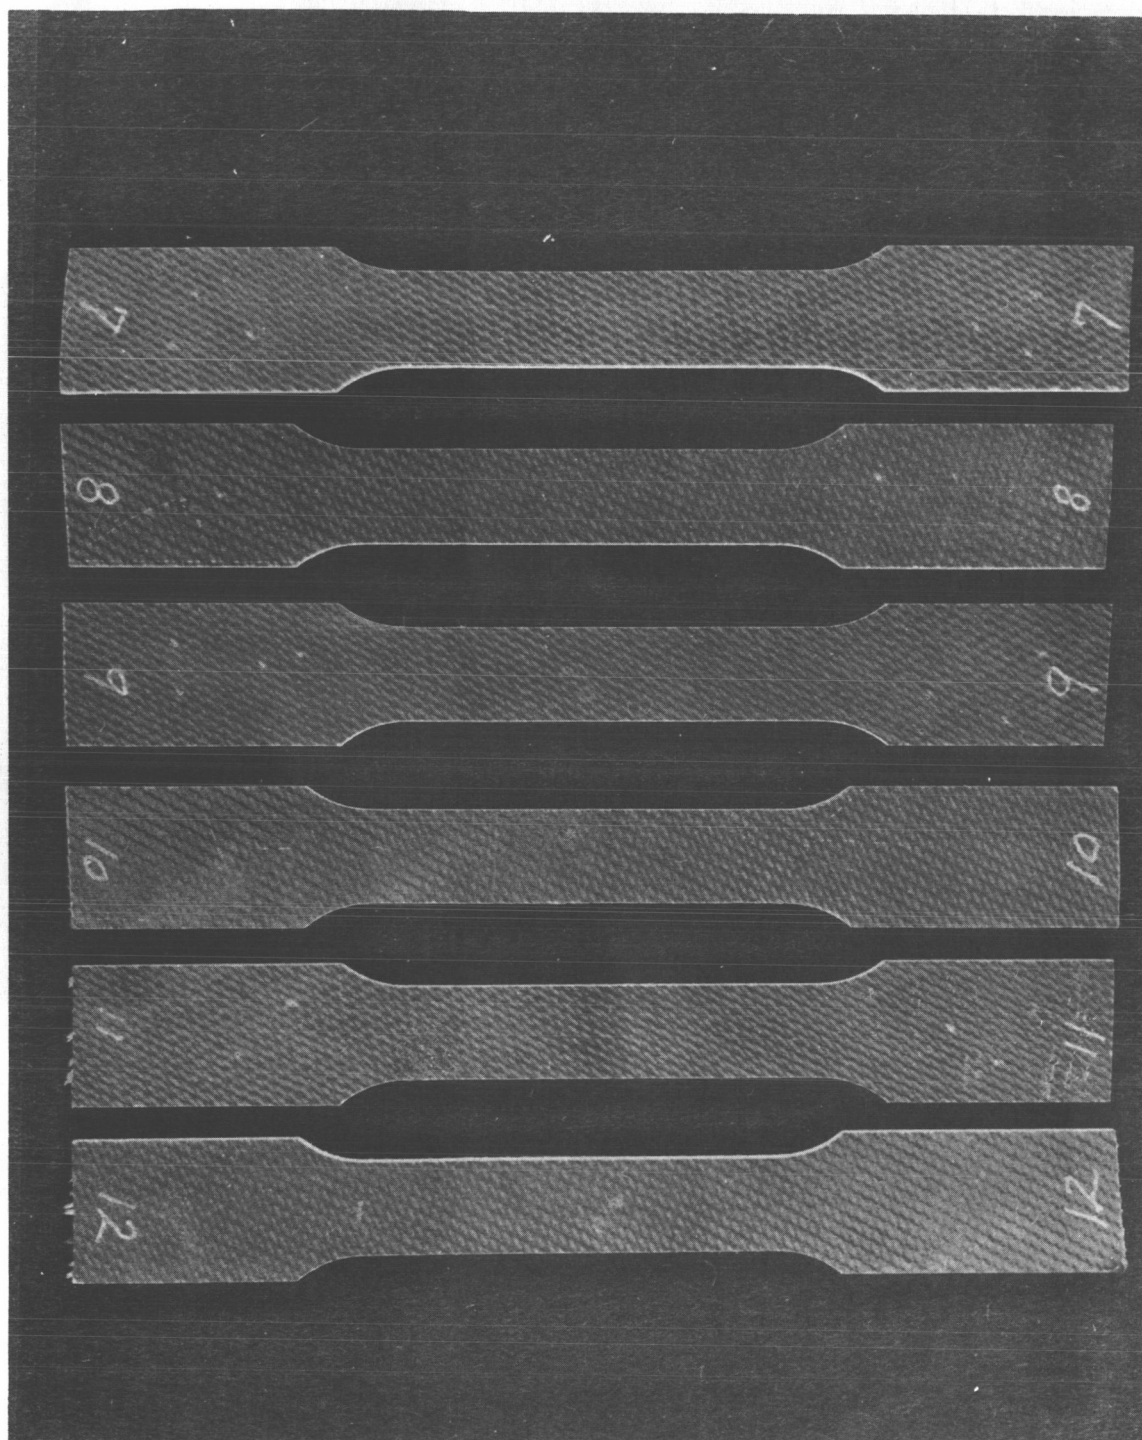
FIGURE 21. MX SE 57 Rubber Modified Phenolic Silica Laminate before ETO/Freon 12. Color Photo (Neg. #32620-67)

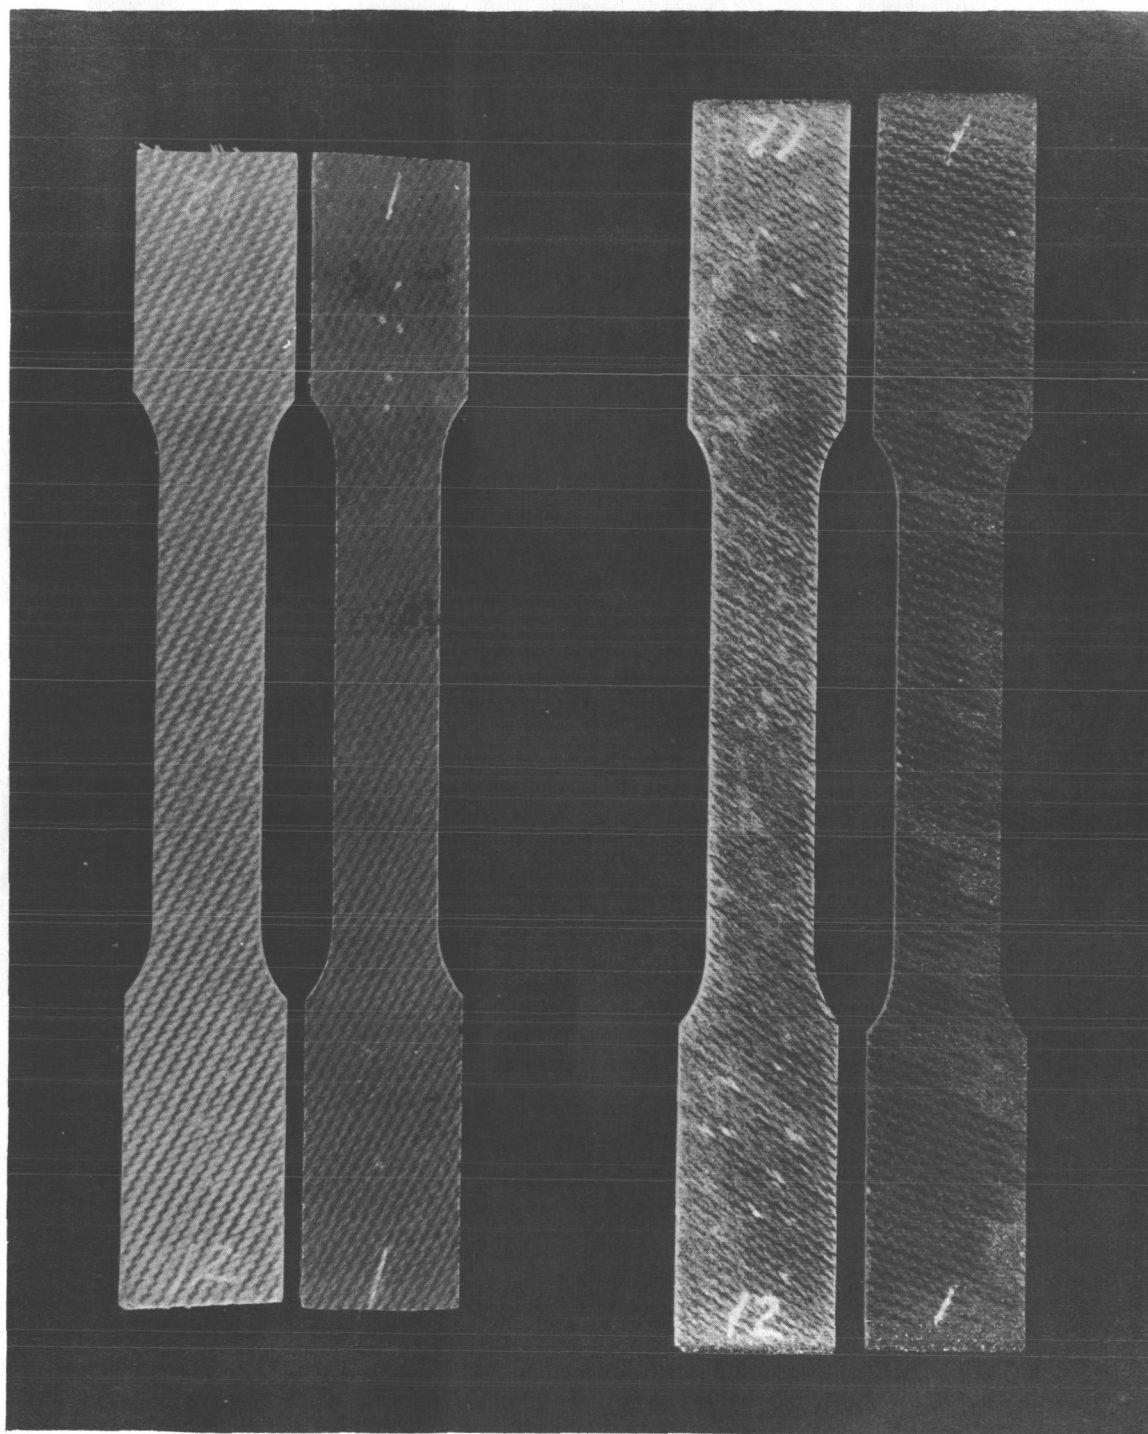
FIGURE 22. Extreme Left - MX SE 57 after ETO/Freon 12. Second from Left - MX SE 57 before ETO/Freon 12. Third from Left - MX 2600 after ETO/Freon 12. Fourth from left - MX 2600 before ETO/Freon 12. Note slight bleaching effects after ETO/Freon 12. Color Photo (Neg. #33023-67)

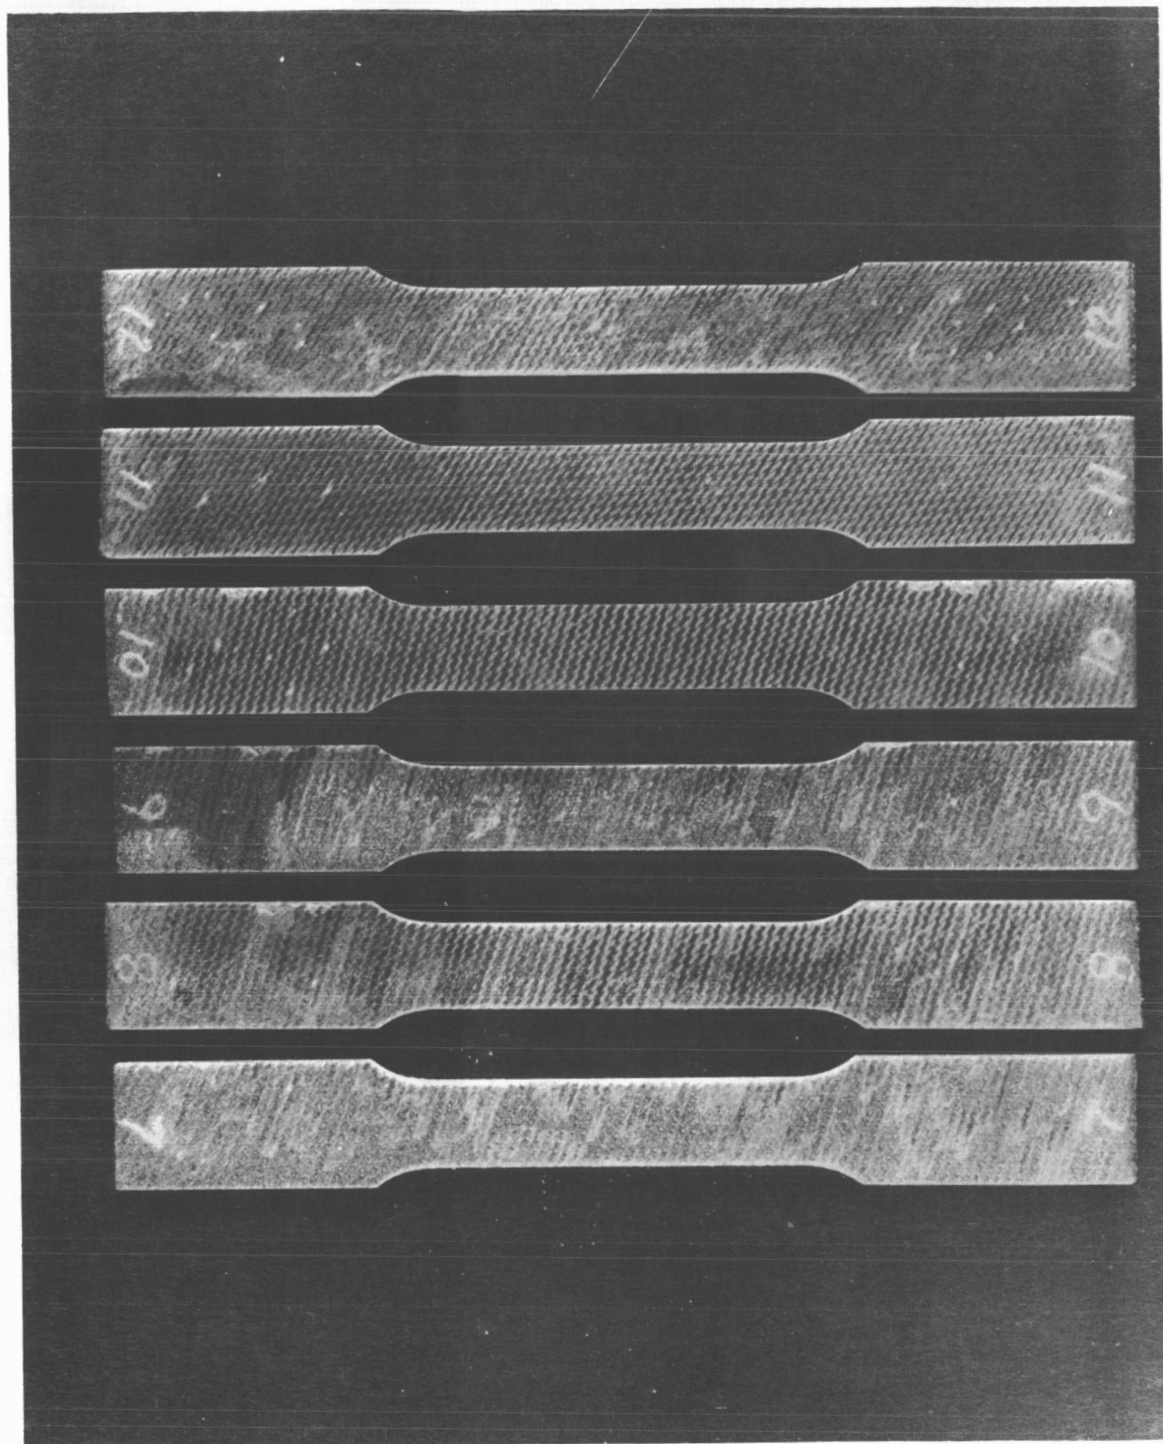
FIGURE 23 - MX 2600 Phenolic Silica Laminate after 7 cycles of ETO/Freon 12.
Note bleaching effect of ETO/Freon 12. Color Photo (Neg. #33013-67)

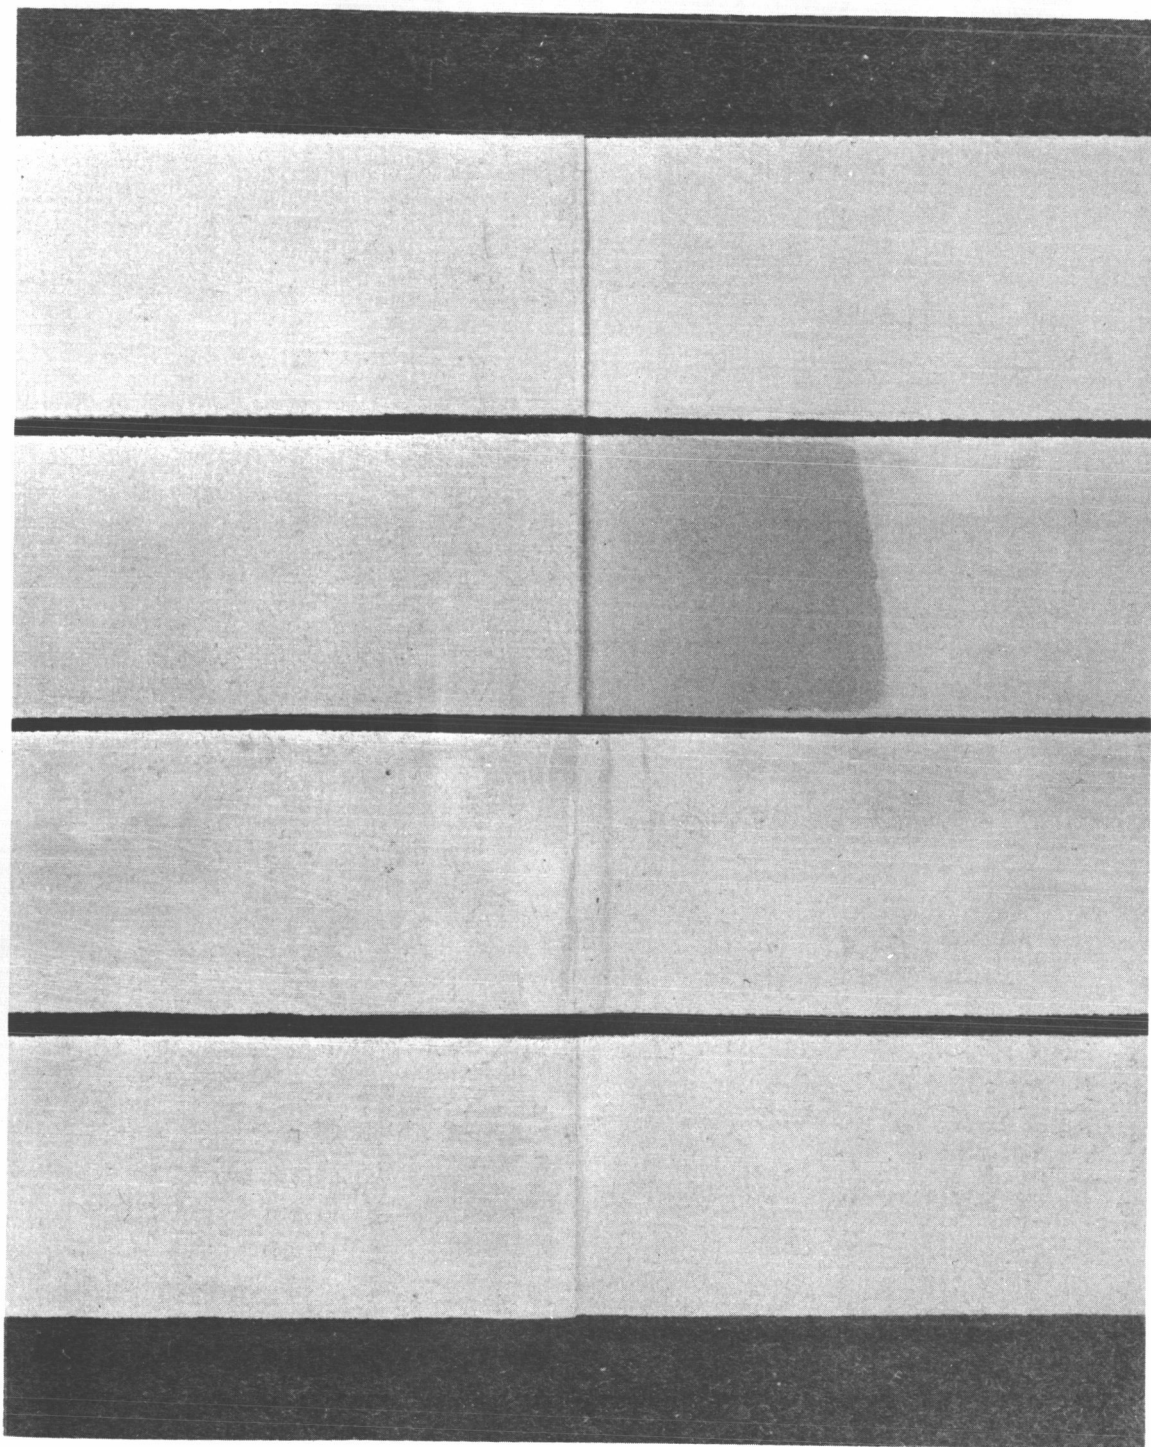
FIGURE 24. Two on Top - Epon 934 Adhesive Lap Shear Specimens. All before ETO/Freon 12. Color Photo (Neg. #32622-67).
Two on Bottom - HT 427 Phenolic Adhesive Lap Shear Specimens.

The Lap Shear specimens of Epon 934 and Adhesive HT 427 were both compatible with ETO/Freon 12. Both adhesives are utilized in various components of the Voyager Engine (Tables 10, 11, and Figures 24 and 25).

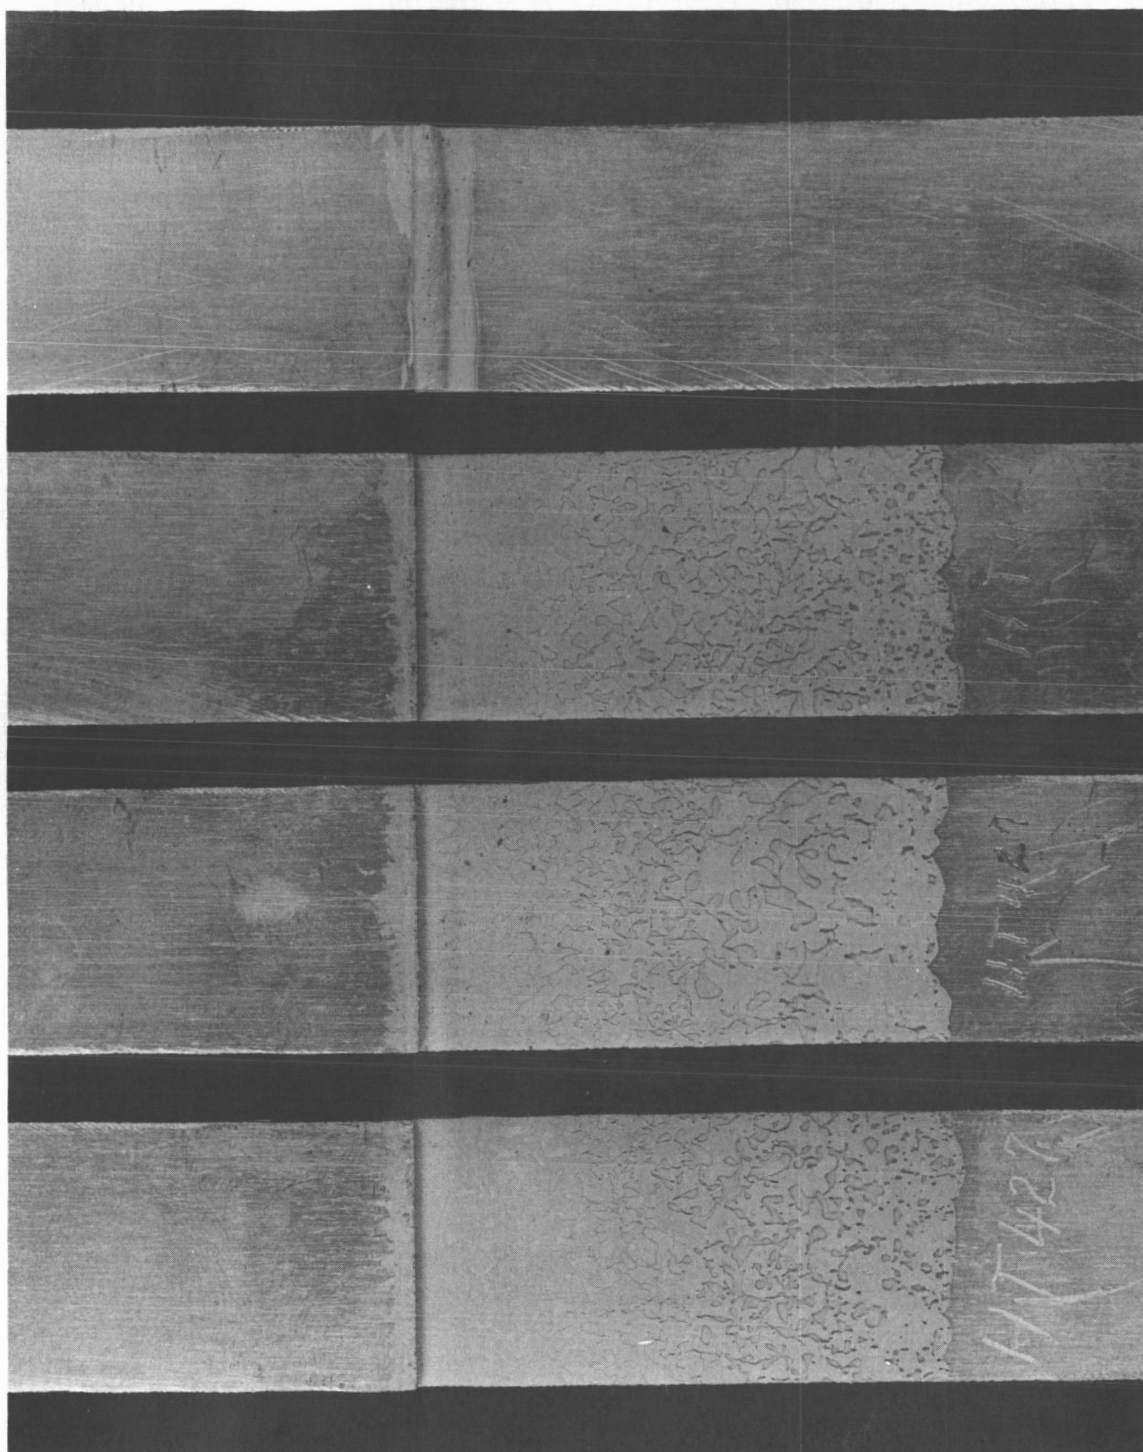
FIGURE 25. HT 427 Phenolic Adhesive Lap Shear Specimens after 7 cycles of ETO/Freon 12. Color Photo (Neg. #33014-67)
